# Manhole Inspection Summary

Manhole # S29CC1034MH

Insp Date: **12/12/06 2:15 PM**

**Location** Address: **709 BERRY ST**

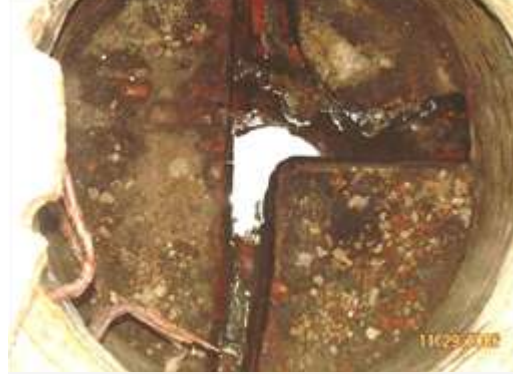
Top View

Bench and Channel debris. Corroded and missing steps.

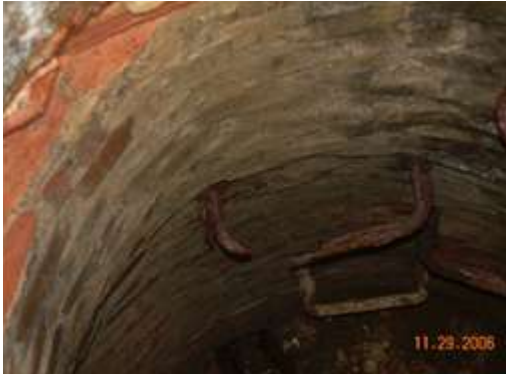
Defect

Infiltration: ☐ None ☒ **Joint** ☐ Cracks ☒ **Mortar** ☐ Roots ☐ Wall

Infiltration: ☐ None ☐ Joint ☐ Cracks ☐ Mortar ☐ Roots ☒ **Wall**

**Steps** Count: **4** Missing: **1** ☒ **Corroded**

Adjustment, Corbel and Barrel infiltration. Corroded and missing steps.

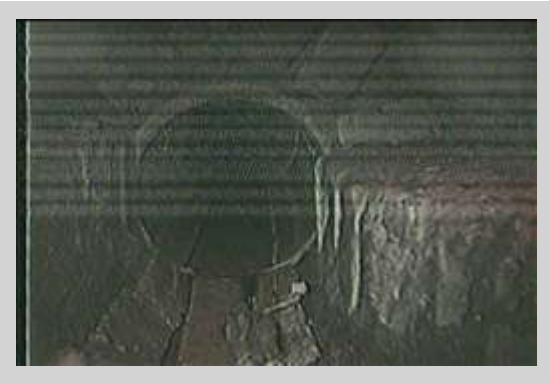
### 8 in. Circular Gravity Sewer Pipe Out @ 12 O'Clock

Infiltration: **Evidence** Pipe Seal Cond: **Cracked**

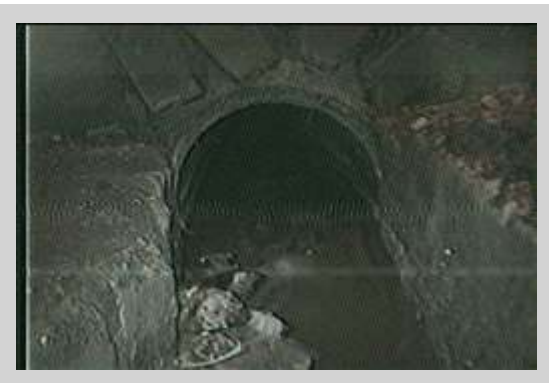
### 8 in. Circular Gravity Sewer Pipe In @ 3 O'Clock

Deposits: ☐ None ☐ Mud ☐ Sludge ☒ **Debris** ☐ Grease

Silt Depth: **0** (in.) Deposits Extent: **Medium**

Infiltration: **Evidence** Pipe Seal Cond: **Unknown**

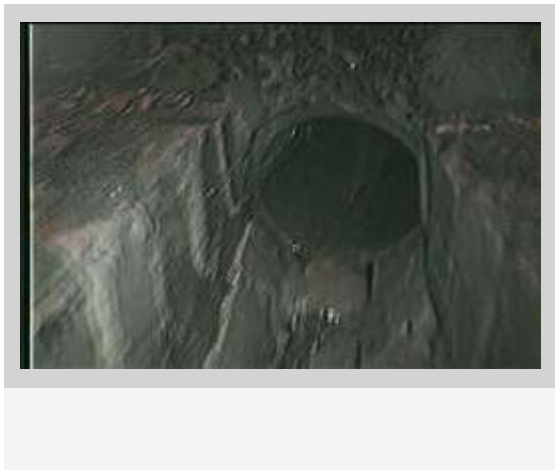
6 in. Circular Gravity Sewer  
Pipe In @ 6 O'Clock

Infiltration: **Evidence** Pipe Seal Cond: **Unknown**
